Press Release

Successful Antenna Repair on WWCR's antenna farm undertaken August 4th and 5th, 2007.

10 August 2007

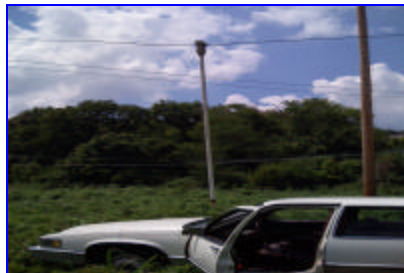
≈ Two issues concerning WWCR's antenna farm were corrected August 4th and 5th, 2007. Issue #1 occurred when the antenna support insulator broke away from the top of it's mast and landed over the feed lines to the other antennae.

ISSUE #1 - The antenna support insulator breaks away from the top of it's mast and lands over the feed lines to the other antennas.

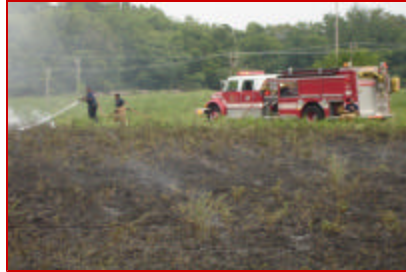
≈ Issue #2 was first believed to be at the actual terminating insulator itself. However, this proved not to be the case. The strain placed on pre-existing splices while performing repair to the first issue caused another element to fail at the other end of the antenna near the terminating insulator. The affected element fell to the ground while on air at 100kW and started a brush fire in the dry field below. Local Volunteer Fire Fighters quickly controlled and extinguished the fire.

ISSUE #2 - Issue #2 was first believed to be at the actual terminating insulator itself which proved not to be the case. The strain put on pre-existing splices while performing repair to the first issue caused another element to fail at the other end of antenna near the terminating insulator. The affected element falls to the ground while on air at 100kW and starts a brush fire in the dry field below. Local Volunteer Fire Fighters quickly control and extinguish the fire.

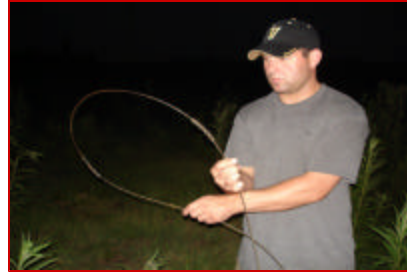
ISSUE #2 - Brady Murray discovers splices such as the one that was later to be discovered to be the point of failure.

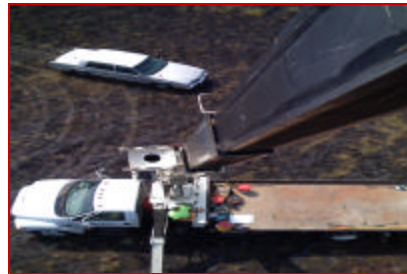
Shot taken from the crane basket by Jason Cooper inspecting the work.
